Formation and Expansion of Salt Patches in the Paddy Field

I. A Salinization Process Observed in the Field

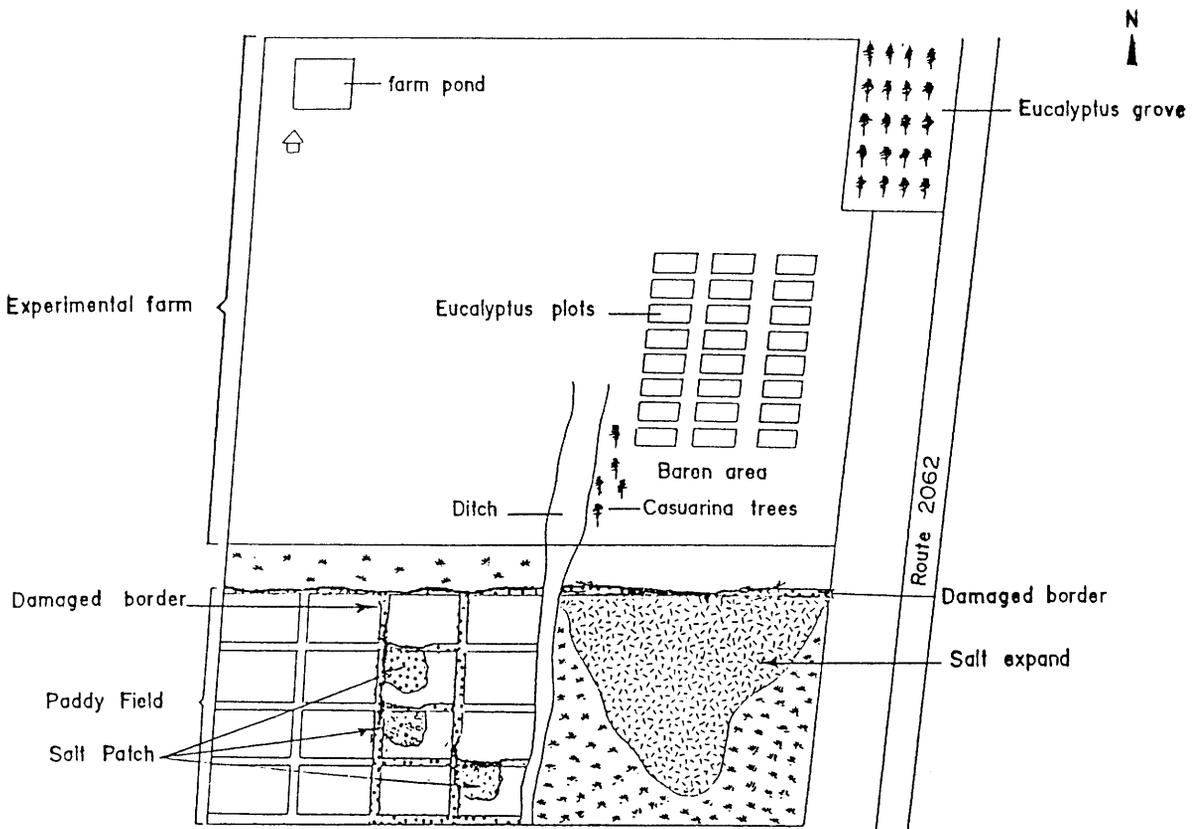
Repeated observations were made from October, 1989 till July, 1990 both inside and outside the newly established experimental farm at Ban Phra Yun, Khon Kaen Province (Figures 1, 2). In this area, paddy fields were present outside the lower end of the newly established experimental farm. The paddy fields close to the experimental farm were strongly salt-affected and abandoned already. Salt patches of various shapes and sizes were recognized inside several paddy fields adjacent to these abandoned paddy fields. These salt patches diminished in size and number and finally disappeared with increasing distance from the newly established experimental farm.

Figure 2 Experimental site at Ban Phra Yun, Khon Kaen Province.

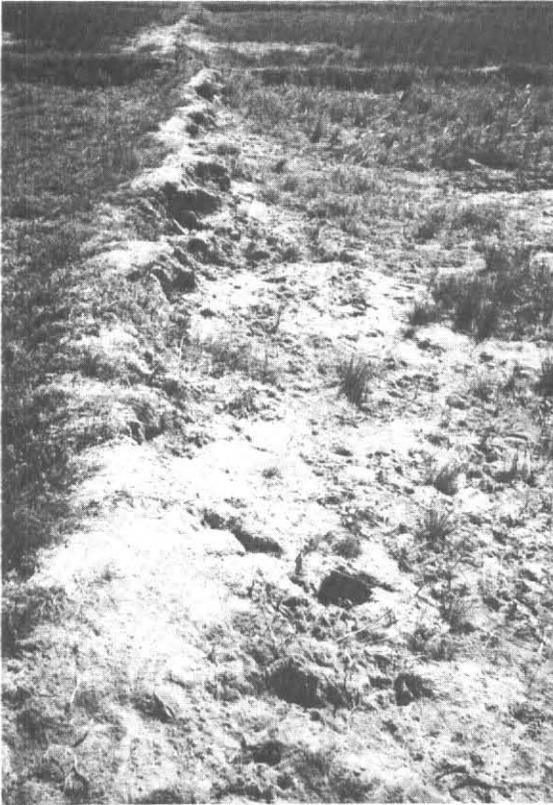
From detailed observations made at beginning of the dry season, 1989, we found that almost all the salt patches were associated with destructed parts of borders of the paddy fields. It appeared that these salt patches were expanded from the destructed parts of the borders (Figure 3). In addition, the severely destructed parts of borders were considered to be located in the passage of runoff water which originated at the moderately to strongly salt-affected places inside the experimental farm and passed through the abandoned paddy fields close to the experimental farm (Figure 4). In other words, the salt patches, the abandoned paddy fields and the moderately to strongly salt-affected places appeared to constitute a saline continuum.

Figure 3 A salt patch associated with a destroyed part of the border.

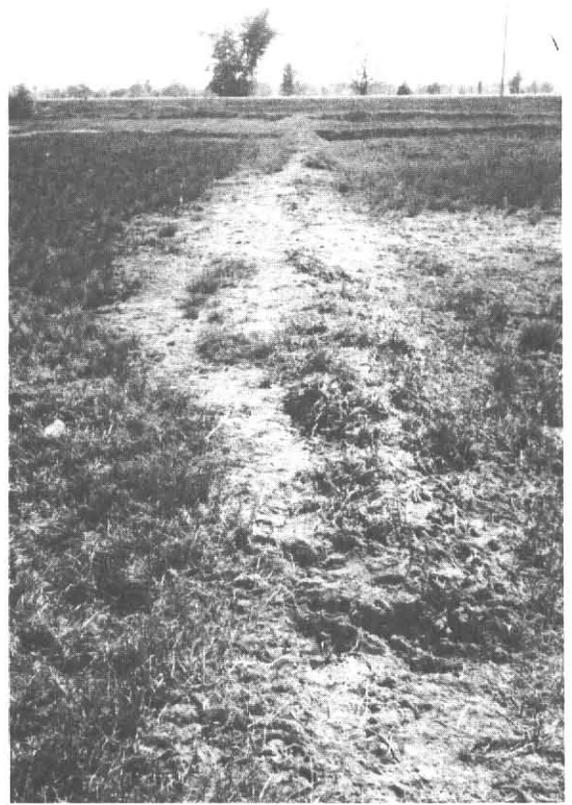
Figure 4 Salt patches extending from a destroyed part of the border.

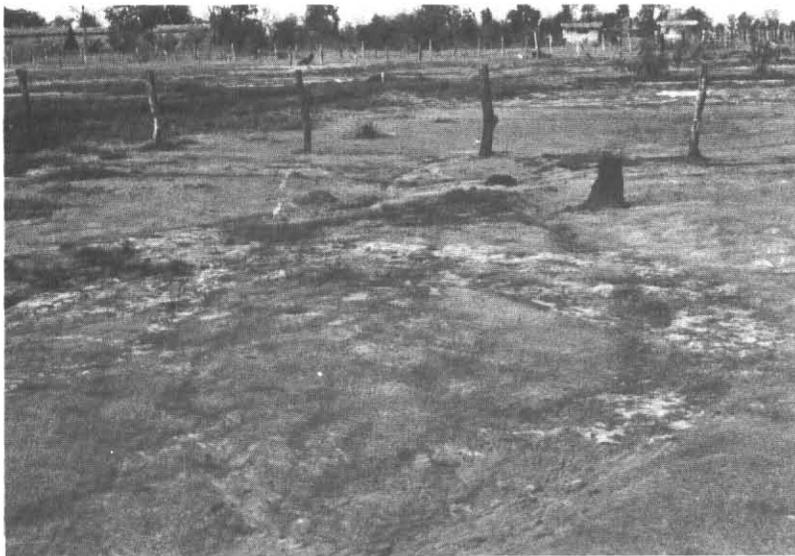
Shallow channels through which runoff water had rushed down were clearly recognized (Figure 5). Sand particles were sedimented in these channels as well as at other parts. At some places, the sandy sediment was covered with a thin layer of dark colored clayey materials. Salt crust was quickly formed on the surface of the dark colored clayey materials after termination of the rains. A part of the eroded particles and salt were transported to the barren areas outside the experimental field. Some of them reached the preexisting salt patches inside the paddy fields (Figure 6). These observations forced us to amend the above mentioned supposition in the following way:

Figure 5 Shallow channels and salt crusts formed by erosion after a shower in the mid-dry season.

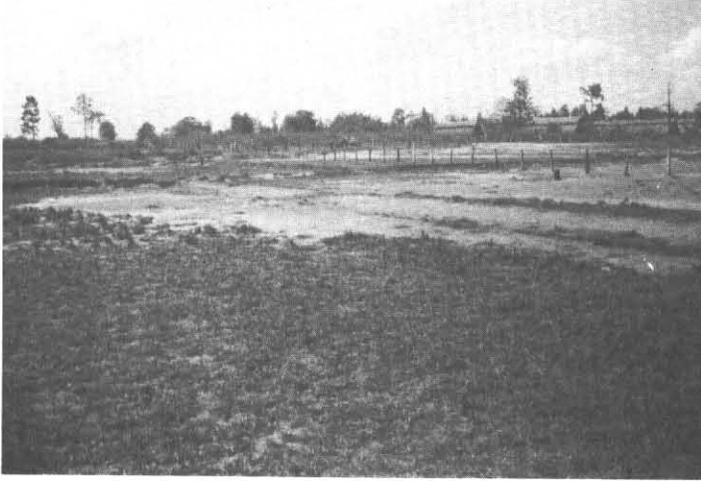
Figure 6 A salt patch in expanded by sedimentation of the salty materials which were originated from the moderately to strongly salt affected place (right hand) and transparented across destructed parts of borders.

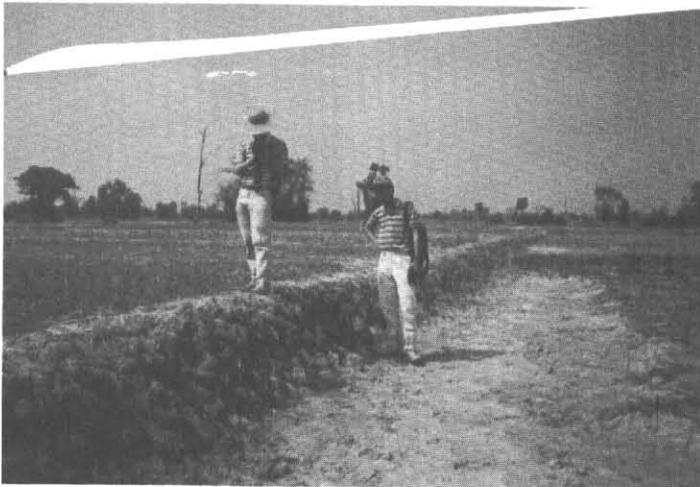
We found that some paddy fields on the slopes were enclosed with newly constructed tall and big borders (about 75 cm high, 100 cm wide) which were composed of pieces (20x20x10cm) of undisturbed plow layer containing rice roots (Figure 7). For the purpose of this construction, the plow layer at narrow bands (about 1.5 m wide) along both sides of the newly constructed borders were completely scraped out. Probably, farmers understood that 1) the damage of their paddy fields were mainly caused by intrusion of the salty materials and 2) tall and tough borders were effective to protect their paddy fields against the damage by this process and might consider pieces of the undisturbed plow layer containing rice roots were not easily disintegrated in the rainy season. Actually, farmers told that salt came down from upper parts of the slope and damaged their lower paddy fields. Unfortunately, the newly constructed tall borders were already partially damaged after being exposed to a few heavy rains in the dry season.

Figure 7 A tall and tough borders.

On the basis of these observations, we can say that enclosing the paddy field with tall and tough borders is really feasible and effective. To materialize this consideration, we must find practical and cheap techniques to construct the tall and tough borders in the salt affected areas. Utilization of a sheet of inexpensive plastic plate or of plastic film may be useful for reinforcing the borders.

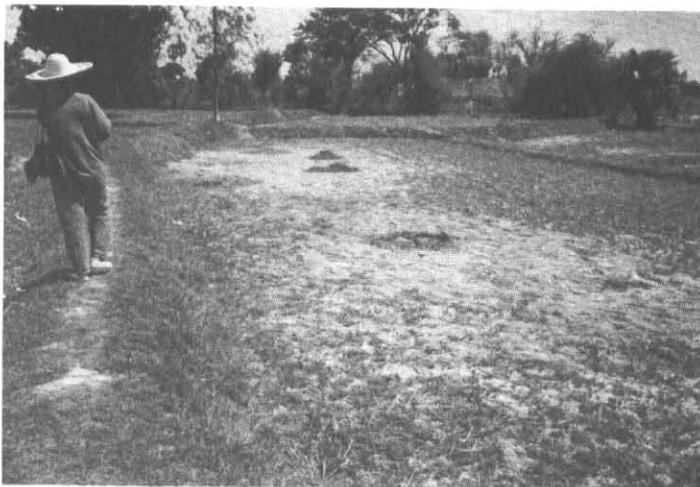
In addition, we noticed another type of salt patches inside paddy fields at Ban Daeng Yai. These salt patches were not associated with destructed border and was mainly distributed inside the paddy fields on the slope (Figure 8). It was frequently present at the foot of an undestructed border between the paddy field concerned and its upper neighboring paddy field. This suggested that these salt patches were supplied with salt from the upper neighbor. Probably, salt in the lower horizons of the upper neighboring paddy field was leached down to certain depth during the period of paddy cultivation and came up from below at the paddy fields concerned in the dry season. The coming up of salt is commonly restricted at the foot of the borders. However, it may be possible for a part of the salt to come up to the place apart from the borders, the distance from the borders being controlled by various

Figure 8 Salt patches not associated with destructed parts of the border.

Preparation of thick impermeable plowsoil or deeply inserting a piece of plastic plate along borders or covering the soil surface with some material (mulching) may be effective for preventing formation and expansion of this type of salt patches. Farmers put piles of compost or of garbage on the surface of the salt patch of this type in the hope that these materials were effective in eliminating the salt patch. To our impression, this farmers' practice was a complex of several unit operations. For instance, the piling of compost or garbage on the soil surface was a kind of mulching with materials containing nutrients and seeds of weeds. Actually, growth of weeds was vigorous on the piles of compost. Some of the weeds growing on the compost extended their territories to the surrounding salt patch. Consequently, the salt patch appeared amended.
