Geophysics under stressed: a case study of Tham Luang Nang Non Cave

Abstract

Keywords: Tham Luang, cave rescue, geophysics, Wild Boars, drilling

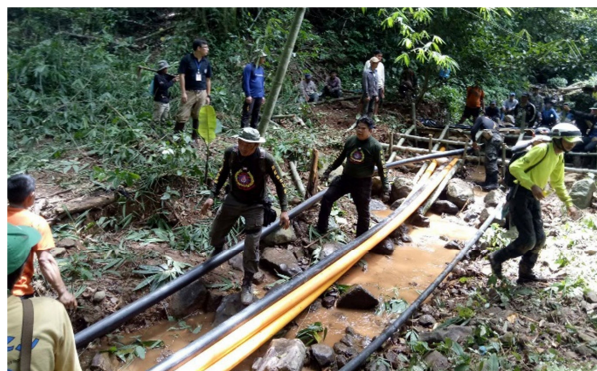
Figure 8 Bypassing the creek at the north of mountain.

The resistivity along the creek at the south of the mountain (Figure 7b) show low resistivity zone indicating possibility of flow channel near the Martin's Point at the depth of 6.0-25.0 m. It may be used as the guideline for the divers' operation. (Figure 8) shows the use of 400 m tubes to diverse the water in the creek from the north of mountain to the downstream.

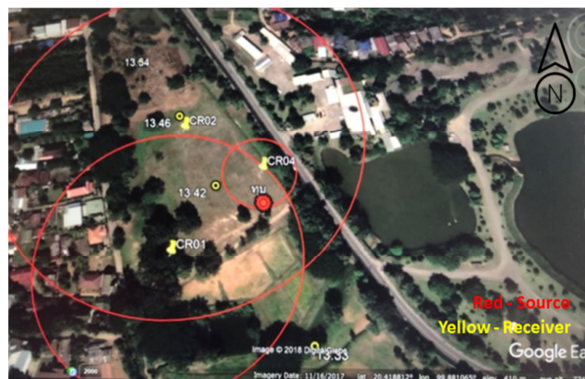
After 3 Wild Boar members were taken out of the cave, groups of scientists and geologists with their doubts in the potential of the seismogram after the test on July 8-9, 2018 had conducted another test on plain area with

Figure 10 Earthquake scan retest map.
